Manhole Inspection Summary

Manhole # S45I2_016MH

Insp Date: **1/7/08 1:53 PM**

Location Address: **1420 Elmtree St** Cross Street: **Fairhaven Ave.**

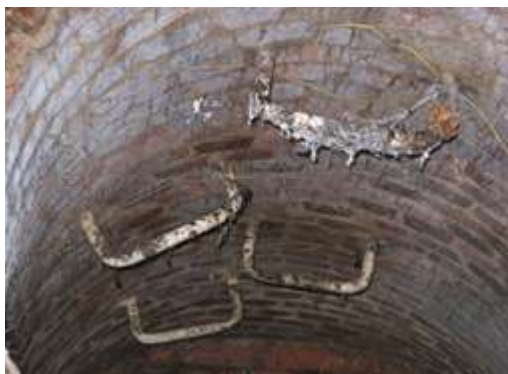
Steps Count: **4** Missing: **0** ☐ Corroded

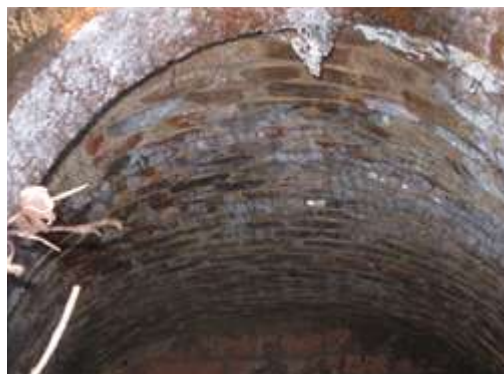
Defect 2

Chimney / Frame Adjustment ☒ Exists Material: **Brick** ☐ Parged Height: **4** (in.)
Condition: ☒ Sound ☐ Cracked ☐ Root Intrusion ☐ Loose Brick ☐ Deteriorated
Infiltration: ☐ None ☐ Joint ☐ Cracks ☒ Mortar ☐ Roots ☒ Wall

Corbel Material: **Brick** ☐ Parged Type: **Concentric/Eccentric**
Condition: ☒ Sound ☐ Cracked ☐ Root Intrusion ☐ Loose Brick ☐ Deteriorated
Infiltration: ☐ None ☐ Joint ☐ Cracks ☐ Mortar ☐ Roots ☒ Wall

Wall

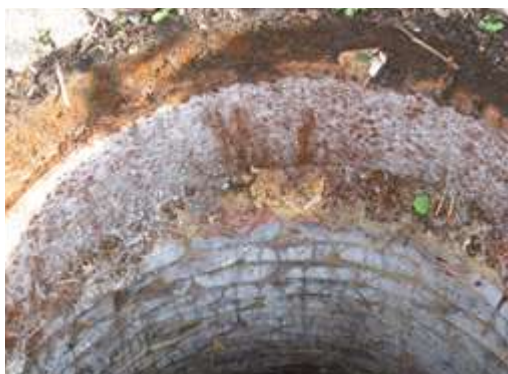
Defect 1

Frame Offset: **1** (in.) Condition: ☒ Sound ☐ Cracked ☐ Leaks

Frame offset

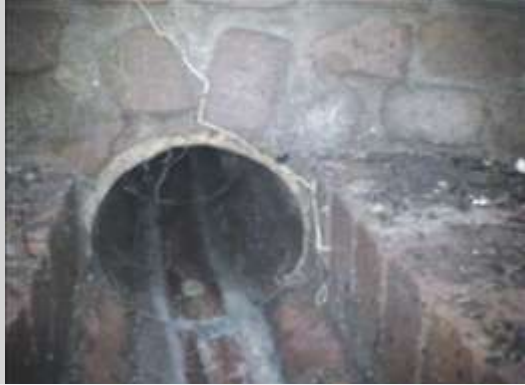
12 O'Clock Outflow

Pipe Height: **9.6** (in.) Rod and Bar (Angled)
Pipe Material: **Clay** ☐ Pipe Lined
Invert Depth: **9.15** (ft.) Flow Characteristics: **Fast**
Deposits: ☒ None ☐ Mud ☐ Sludge ☐ Debris ☐ Grease
Silt Depth: (in.) Deposits Extent:
Infiltration: **None** Pipe Seal Cond: **Sound**

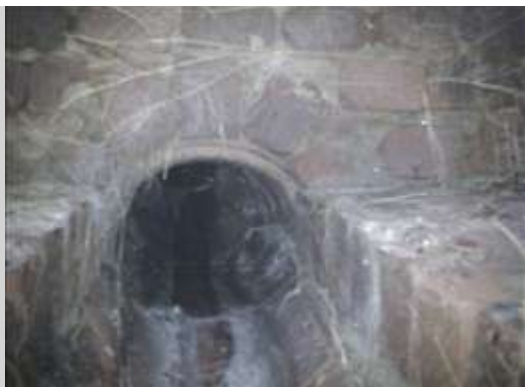
6 O'Clock Inflow

Pipe Height: **9.6** (in.) Rod and Bar (Angled)
Pipe Material: **Clay** ☐ Pipe Lined
Invert Depth: **8.90** (ft.) Flow Characteristics: **Fast**
Deposits: ☒ None ☐ Mud ☐ Sludge ☐ Debris ☐ Grease
Silt Depth: (in.) Deposits Extent:
Infiltration: **None** Pipe Seal Cond: **Sound**
